# Manhole Inspection Summary

Manhole # S190\_\_001MH

Insp Date: **3/14/08 1:16 PM**

**Location** Address: **2101s pulaski-s smallwood alley**

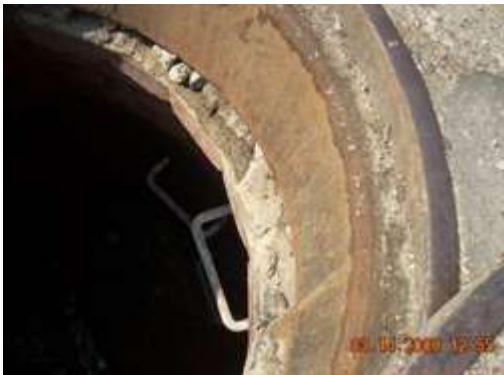
Defect 3

Offset: **1** (in.)

frame offset

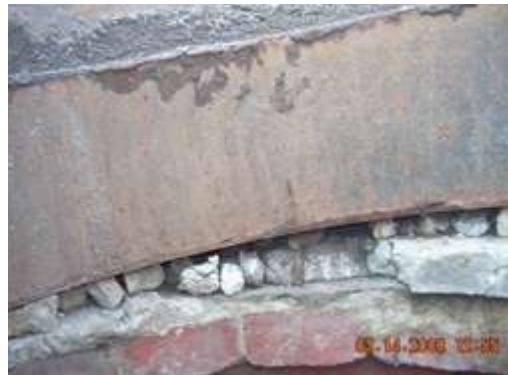
Defect 2

Condition: ☐ Sound ☐ Cracked ☐ Root Intrusion ☐ Loose Brick ☒ **Deteriorated**

deteriorated chimney

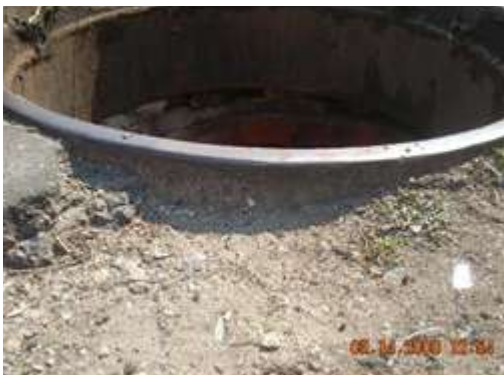
Defect 1

Diameter: **24** (in.) Length: **0** (in.) Dist A/B Grade: **1** (in.)

frame above grade 1 inch

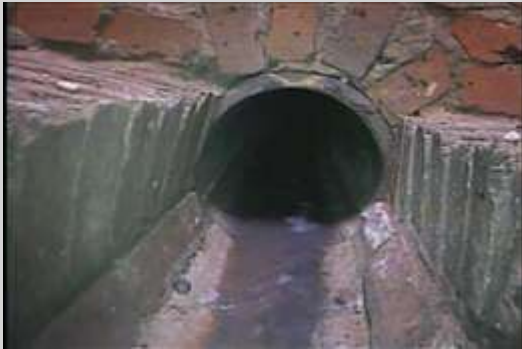
12 O'Clock Outflow

Pipe Height: **8.4** (in.) Rod and Bar (Angled)  
Pipe Material: **Clay** ☐ Pipe Lined  
Invert Depth: **7.23** (ft.) Flow Characteristics: **Slow**  
Deposits: ☒ None ☐ Mud ☐ Sludge ☐ Debris ☐ Grease  
Silt Depth: **0** (in.) Deposits Extent:  
Infiltration: **None** Pipe Seal Cond: **Cracked**
